## Analysis of defects in stainless steel piping

R. Janulionis\*, G. Dundulis\*\*, R. Karalevičius\*\*\*

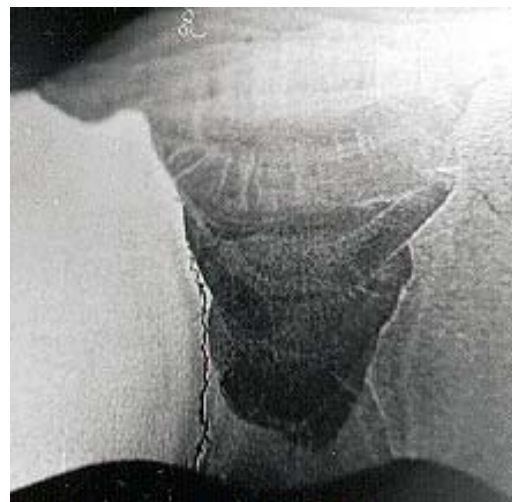
The IGSCC cracks in MCC austenitic piping of Ignalina NPP appear at the inner surface in HAZ near to weld root and grow to outside close to fusion line (Fig. 1) [1]. The HAZ material is susceptible to IGSCC and sensitised in most cases. The sensitisation occurs due to overheating during welding and is an important factor in the cracking behaviour.

Fig. 1 IGSCC of piping welded joints heat affected zones

According to investigations, the crack growth stops reaching zone of low sensitisation approximately in the middle of pipe wall. It determines the maximal height of detected cracks of 8-10 mm. However, it is necessary to mention that is not known with a certainty if only degree of sensitisation stops a crack grow. If one waits long enough without inspections there are no guaranties that the crack will not penetrate the wall thickness. Up to now no leakage has occurred.

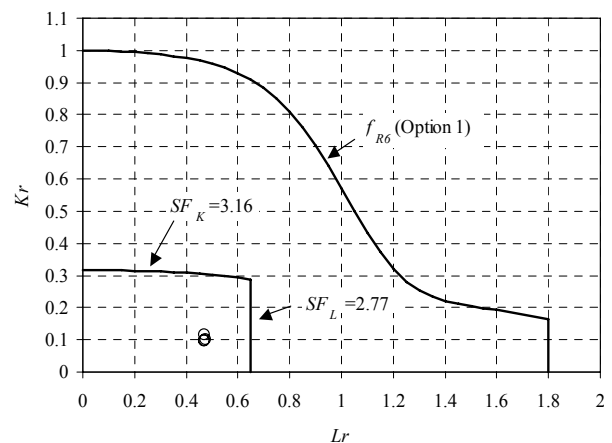
During planned preventive maintenance 126 defects were detected by ultrasonic nondestructive method in the MCC in 2008 [2]. All 126 defects were evaluated using the methodology described in chapter 2. In case of big amount of defects and calculation data only few of them were presented in this paper. Only defects where the biggest load combination occurs and the deepest defect are shown. The evaluation results of detected defects in the SH-PH (bypass between suction header and pressure header) piping are shown in Fig. 4.

Evaluated cracks are presented by point in this figure. Four defects were detected in this section of piping. The depth and length of the first defect respectively was 2 mm and 50 mm, for the second 2 mm and 70 mm, for the third 2 mm and 40 mm and for the fourth 3 mm and 40 mm. The stresses level in welds where these defects were detected are: the primary membrane stress  $S_m = 36.5 \text{ MPa}$ , the primary bending stresses due to pressure and dead weight  $S_b(p) = 10.9 \text{ MPa}$ , the bending stress due to thermal expansion  $S_b(T) = 55.1 \text{ MPa}$ .

Fig. 4 Evaluation of cracks in the SH-PH piping

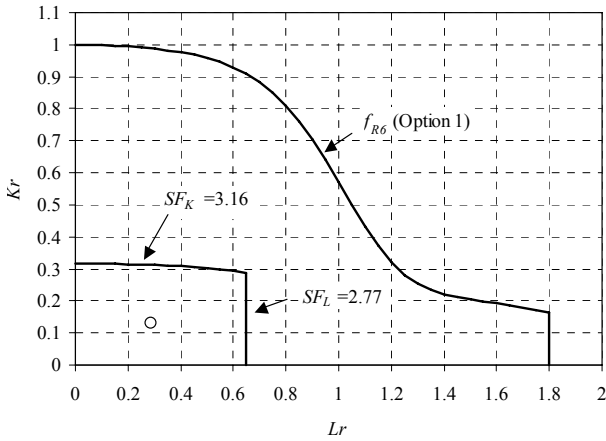
The biggest defect detected during this inspection was in downcomers (DC). This crack was 54 mm long and 10.5 mm depth. The stress in this defected level are  $S_m = 30 \text{ MPa}$ ,  $S_b(p) = 3.4 \text{ MPa}$  and  $S_b(T) = 25.3 \text{ MPa}$ . The evaluation of this crack is shown in Fig. 5. Evaluated cracks are presented by point in this figure.

Fig. 5 Evaluation of crack in DC

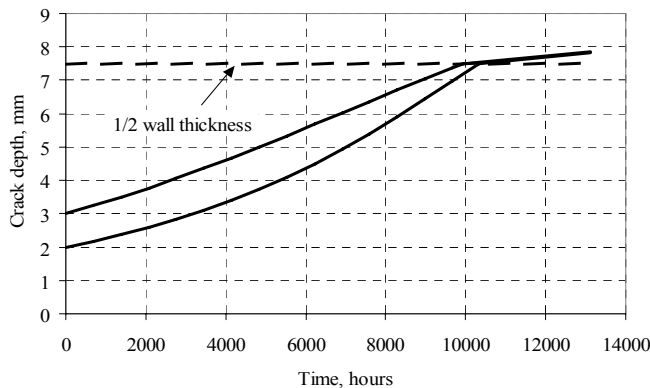
Crack growths due to IGSCC mechanism for detected defects in the SH-PH piping are shown in Fig. 6. As you can see in the figure detected defects were 2 mm and 3 mm depth. The growths of defects until they reach 1/2 pipe wall thickness were calculated using Eq. (3). The defects with initial depths of 2 mm 1/2 pipe wall thickness reach after 10324 hours (1.18 years) and the defects with initial depth of 3 mm reach it after 9943 hours (1.14 years). When the defects reach 1/2 wall thickness the defect depths growth speed slows down (as it was explained in chapter 2) and after 1.5 years of exploitation will respectively reach 7.82 mm and 7.86 mm.

Fig. 6 Crack growth evaluation due to IGSCC mechanism in the SH-PH piping

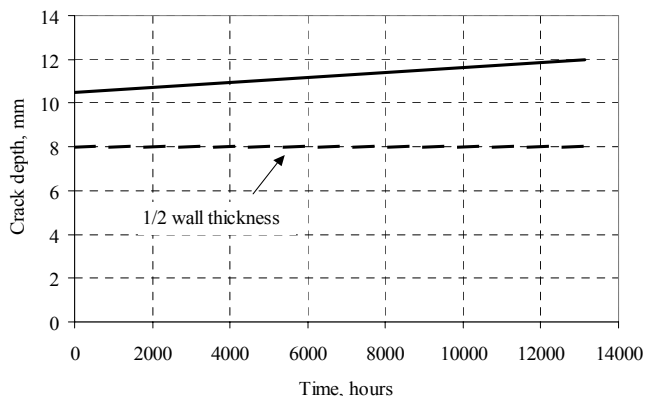
Fig. 7 Crack growth evaluation due to IGSCC mechanism in DC

Crack growth due to IGSCC mechanism for detected defect in the DC is shown in Fig. 7. Detected defect depth was 10.5 mm which is deeper than 1/2 pipe wall thickness. This means defect depths growth speed is 1 mm/year and after 1.5 years the defect depth will reach 12 mm.

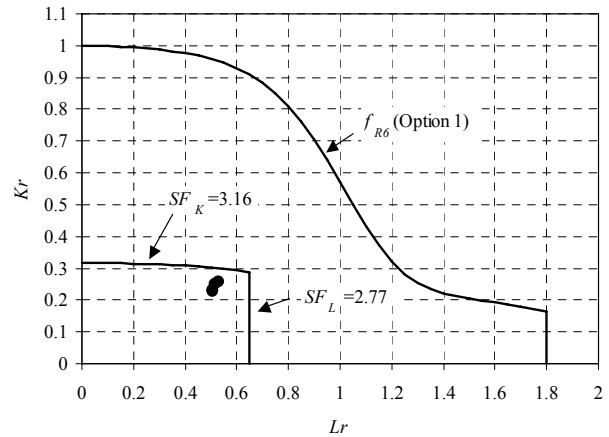
Evaluation of defects after 1.5 years of operation is presented in FigS. 8-9. Evaluated cracks are presented by black point in this figure.

Evaluation of the defects showed that all 126 detected defects and defects after 1.5 year of operation are in acceptable region. That means that all welds in MCC can be left without repairing.

Fig. 8 Evaluation diagram for cracks after 1.5 years operation in the SH-PH piping

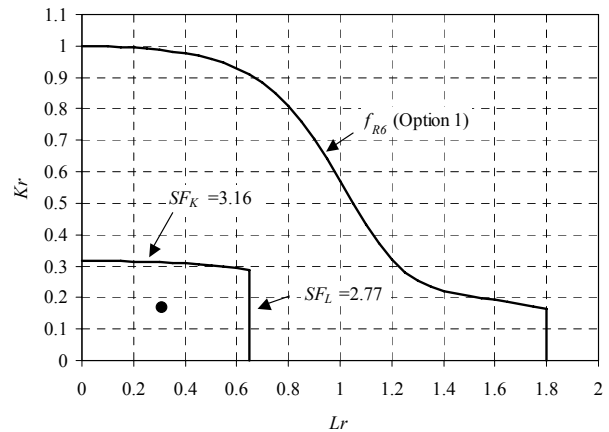
Fig. 9 Evaluation diagram for cracks after 1.5 years operation in DC
