Investigation of fracture of carbon steel springs used for furniture application

R. Kandrotaitė Janutienė

Kaunas University of Technology, Studentų str. 56-323, 51424 Kaunas, Lithuania, E-mail: raskand@ktu.lt

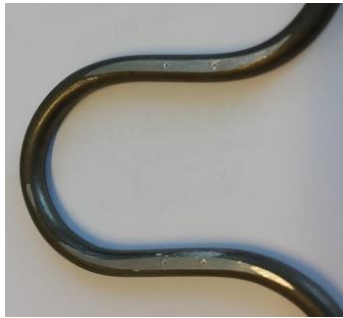
Rockwell hardness of spring steel was examined by Universal hardness meter VERZUS 750CCD. For the purpose to eliminate the possible error of hardness measurement concerning cylindrical shape of wire, the surface of tested piece was ground approximately 0.5 mm from the both sides to make it flat (Fig. 1).

Fig.1 Prepared surface of specimen for hardness measurement

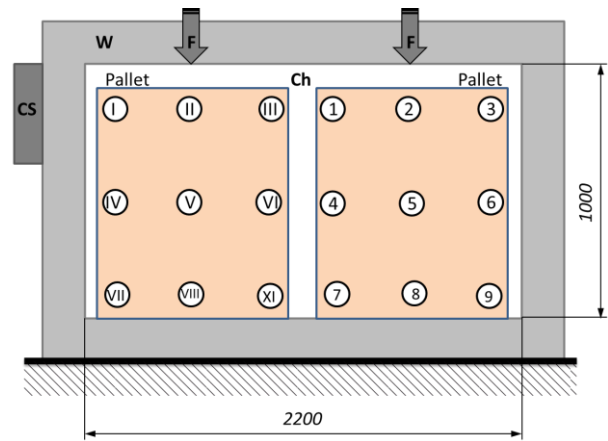
As the industrial heating furnace was designed with the thermocouple installed in the wall near the control system block and two big pallets of springs were heated during one tempering process, test for examining of reached temperature of wire springs was performed. 18 rods of wire (group A) were arranged into the pallets according scheme presented in Fig. 3 and tempered in the industrial furnace. Before tempering, the black coating of phosphates was removed from the surface of specimens. During tempering the surface of cleaned specimens covered with different thickness of oxides that gave different colour.

Fig. 3 Schematic front view of arrangement of wire rods as specimens inside pallets of springs placed into the chamber of furnace. Arbitrary signs: CS – control system; W – furnace wall containing 24 heating elements; F – fan; Ch – furnace chamber

The specimens of group A tempered in industrial furnace at 300 °C for 45 min are presented in Fig. 8. Their numbering is shown in Fig. 3. The comparison of colours of oxide films between specimens tempered in industrial furnace and laboratory one are listed in Table 4 and the map

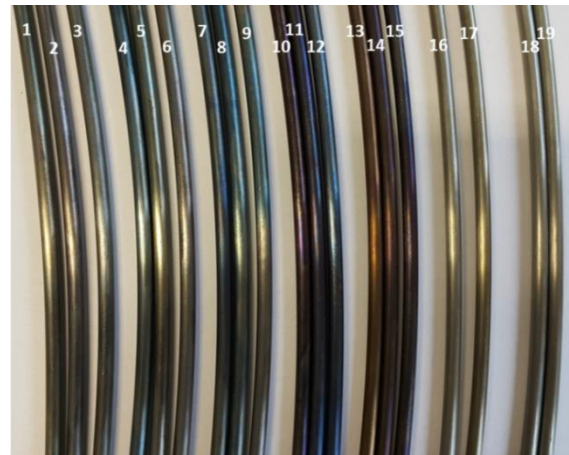
The same was made with specimens (group B) with welded chromel-alumel thermocouples of thickness 0.3 mm tempered in the laboratory furnace at different temperature and for different duration (Fig. 4). The tempering regimes are presented in Table 3. Tempering regimes (temperature and duration) were chosen according most recommended in different scientific works [1-5].

Duration of heating at mentioned temperature increases from left to right, min

Fig. 4 Variation in oxide film colour of specimens of group B tempered in laboratory furnace. Colour of oxide film: 350°C – yellowish with grey shade; 320 °C – yellowish with slight bluish shade; 300 °C – yellowish with intense blue shade; 275°C – intermediate of purple and blue; 250°C – intense brown; 200°C – intense yellow; 175°C – yellow

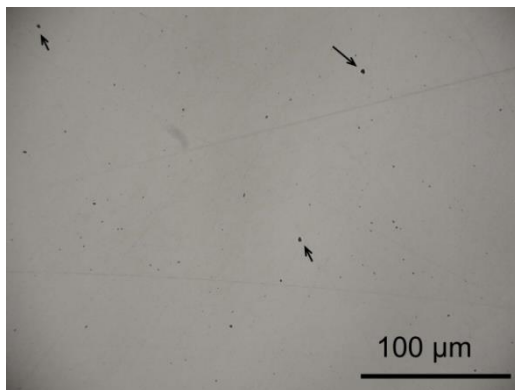
Polished and not etched surface of the samples showed very few and small oxides just several micrometres in size (Fig. 5) that could not be a reason of fracture of springs. Oxides could be classed to index $i = 0.5$ (the lowest index for globular oxides) according standard ISO 4967:2013 [13].

Fig. 5 Non-metallic inclusions found in spring steel. The biggest ones are shown by arrows

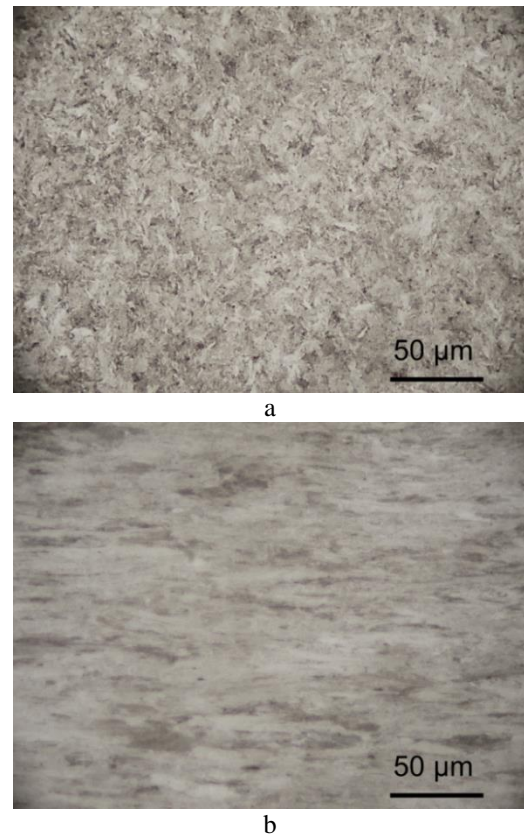
Etching of the surface of samples revealed the fibrous microstructure in longitudinal cross-section and fine microstructure in transverse direction (Fig. 6). The hardness was determined to be 46-48 HRC corresponding with the data (~46.9 HRC) found in literature [14]. Several scientific articles have identified the microstructure as fine pearlite (sorbite) [5, 15-17], also, some traces of bainite may exist [5, 18]. Precise examination of microstructure of steel wire requires other investigation techniques such as X-ray analysis or micro-indentation [5, 19].

Fig. 6 Microstructure of patented and tempered hyper-eutectoid steel wire: a) transverse section, b) longitudinal section

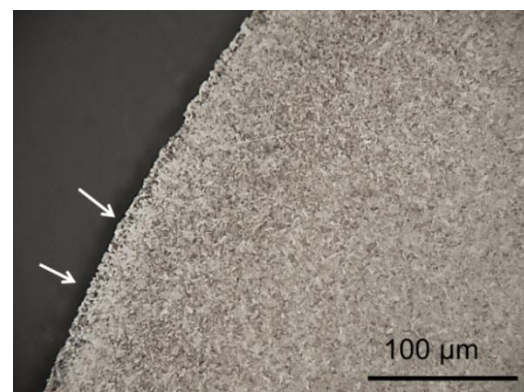
For examination of decarburization all transverse samples were observed. According standard EN 10270-1 [10], permissible depth of decarburization for the wire with 3.8 mm diameter should not exceed 1.5 % of diameter (57 μm). Among six transverse samples just one showed the signs of decarburization (Fig. 7). It could be identified as brighter strip with thickness of 30-40 μm near the surface of sample. The found decarburization did not exceed the permissible limits mentioned in standard EN 10270-1 but in spite of that it showed facilitated conditions of crack

initiation and propagation, thus the fatigue resistance may be decreased in some places of spring [20].

Besides decarburization small surface roughness also can be seen in Fig. 7. Roughness of wire surface can be a cause of crack propagation, too.

Fig. 7 Decarburized surface of patented and tempered steel wire

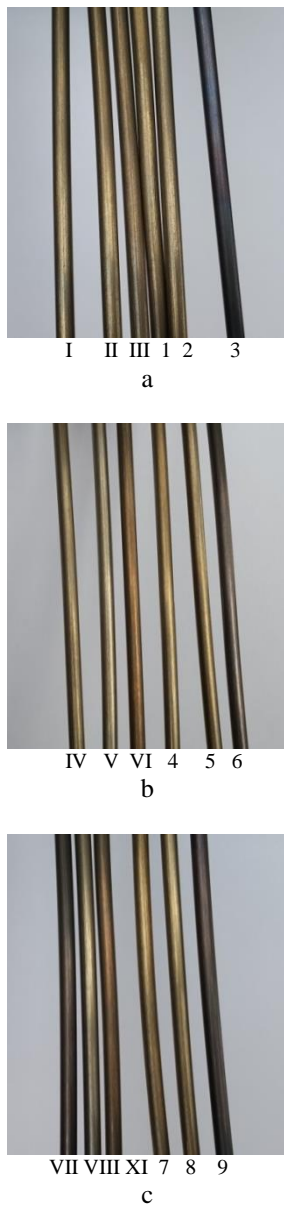
After tempering of the specimens of group A (industrial furnace), the specimens were compared with the ones of group B and very approximate tempering temperature was determined for the specimens of group A. The colour of oxide film of the specimens of group A showed that during heating in industrial furnace (with set parameters $T = 300\text{ }^{\circ}\text{C}$, $t = 45\text{ min}$) the springs could reach

moderately 220-240 °C temperature as their colour was obtained yellow just several of them that were arranged at the right side of the furnace chamber (specimens No. 3, 6 and 9, Fig. 3) have reached 280-300 °C.

Fig. 8 Variation of oxide film colour of specimens of steel wires tempered in industrial furnace at set temperature 300 °C for 45 min (group A). Numbers below pictures show specimens' numbering according arrangement scheme in furnace (Fig. 3). Approximate colours: a – I, II, 1 and 2 were intense yellow; III was yellow with brown shade; 3 was blue; b – IV, V, 4 and 5 were yellow with different intensity, VI was slight brown; 6 was blue with brown shade; c – VII was brown with blue shade; VIII was intense yellow; XI was intense brown; 7 and 8 were yellow with brown shade; 9 was blue

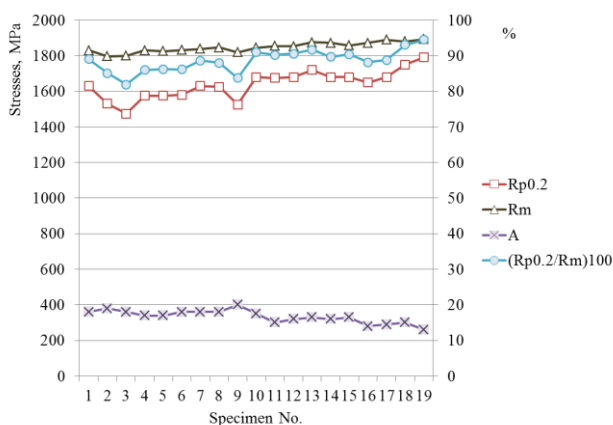
Tensile test was performed for specimens of group B. The results of tensile test are listed in Table 5. The lowest strength was obtained for steel wire specimen tempered at 300 °C for 60 min (Fig. 11). This may be caused by tempering embrittlement at this temperature [7].

Fig. 11 Mechanical properties of steel wires tempered at different temperatures heating for various durations (group B, Table 5)

3. Tensile test of specimens tempered at different temperatures for various durations showed that the best mechanical properties could be achieved when tempering regime is 250-275°C for 60-90 minutes.
