New deep groove ball bearings high frequencies vibration testing

V. Barzdaitis*, V. V. Barzdaitis**, R. Maskvytis***, A. Tadžijėvas****, M. Vasylius*****

*Kaunas University of Technology, A. Mickevičiaus str. 37-304, 44239 Kaunas, Lithuania,

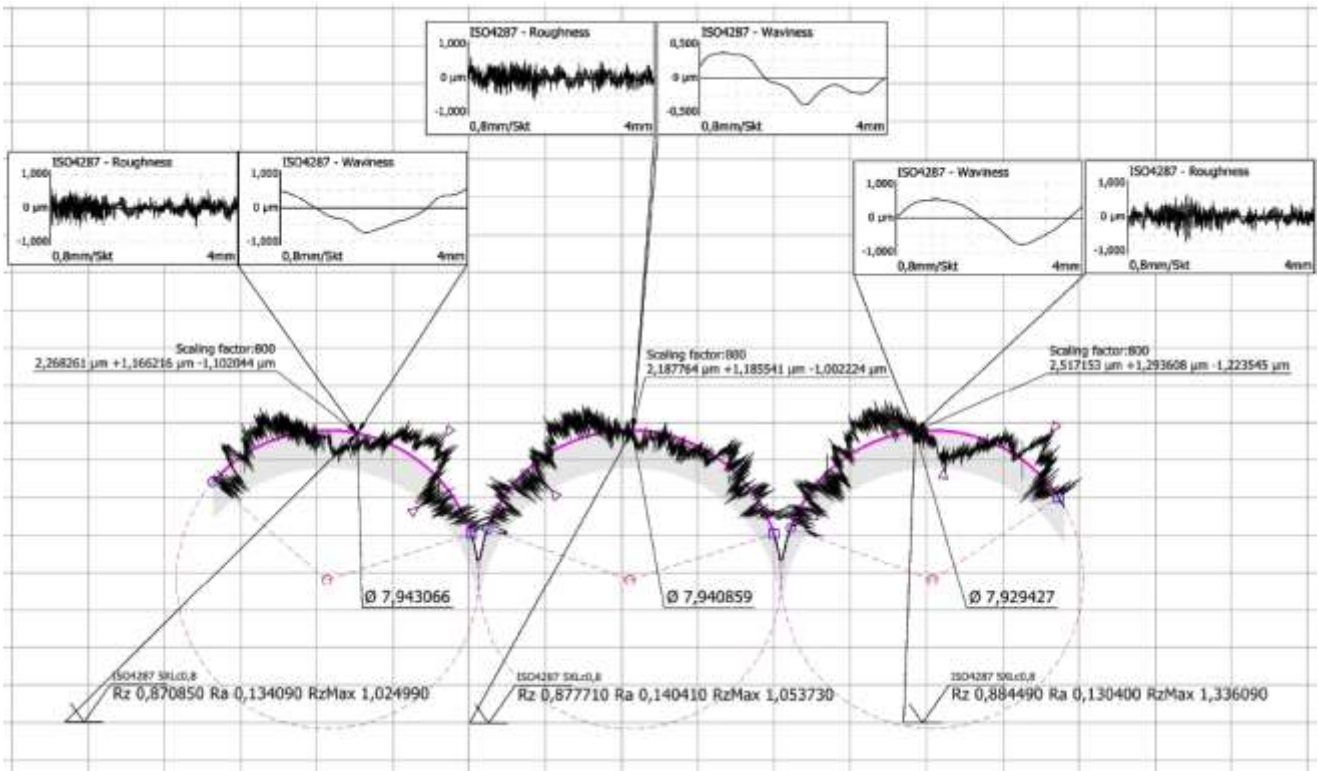
Fig. 1 Bearing balls geometric dimensions: roughness R_a , R_z , R_{zMax} and waviness W_s values of three balls of the tested bearing; balls' nominal diameter (7.933 ± 0.0004 mm) with deviations: 7.943066 mm ($2.266 \mu\text{m}$); 7.940859 mm ($2.18764 \mu\text{m}$); 7.929427 mm ($2.517153 \mu\text{m}$); micro-defects (surface roughness R_z 0.87085-0.88449 μm , R_{zmax} 1.02499-1.33609 μm) and waviness $W_s < \pm 0.5 \mu\text{m}$ (by courtesy of Craft Bearing Corp.)

6. Tested bearings contacting elements with the surfaces roughness R_z , R_{zmax} , waviness W_s , misaligned races and off-size rolling elements, roundness' were measured with high quality devices disassembling tested bearings, (Fig. 1). Measurements of inner raceway, outer raceway and balls roundness, waviness and roughness were provided with high accuracy measurement devices. Bearing 6205 C3P6 elements measurement results indicated the existence of micro-defects (surface roughness R_z , R_{zmax} , R_a waviness W_s) in the new bearing elements (Fig. 1, Table).

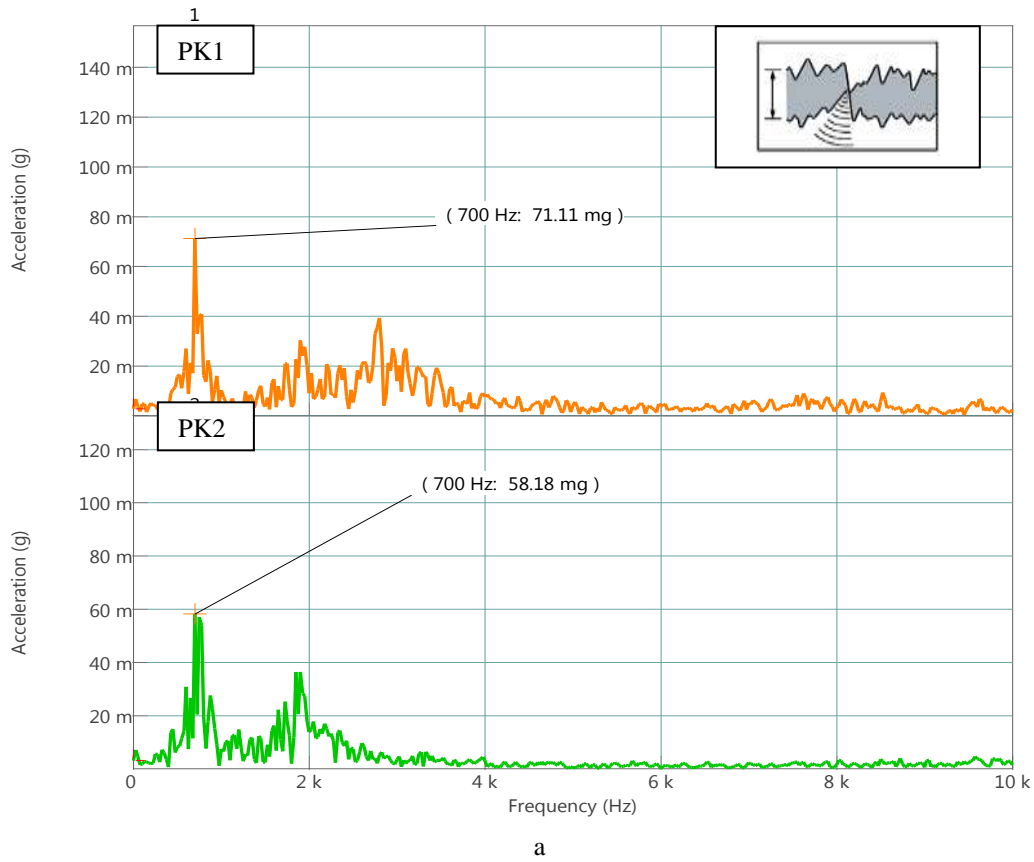
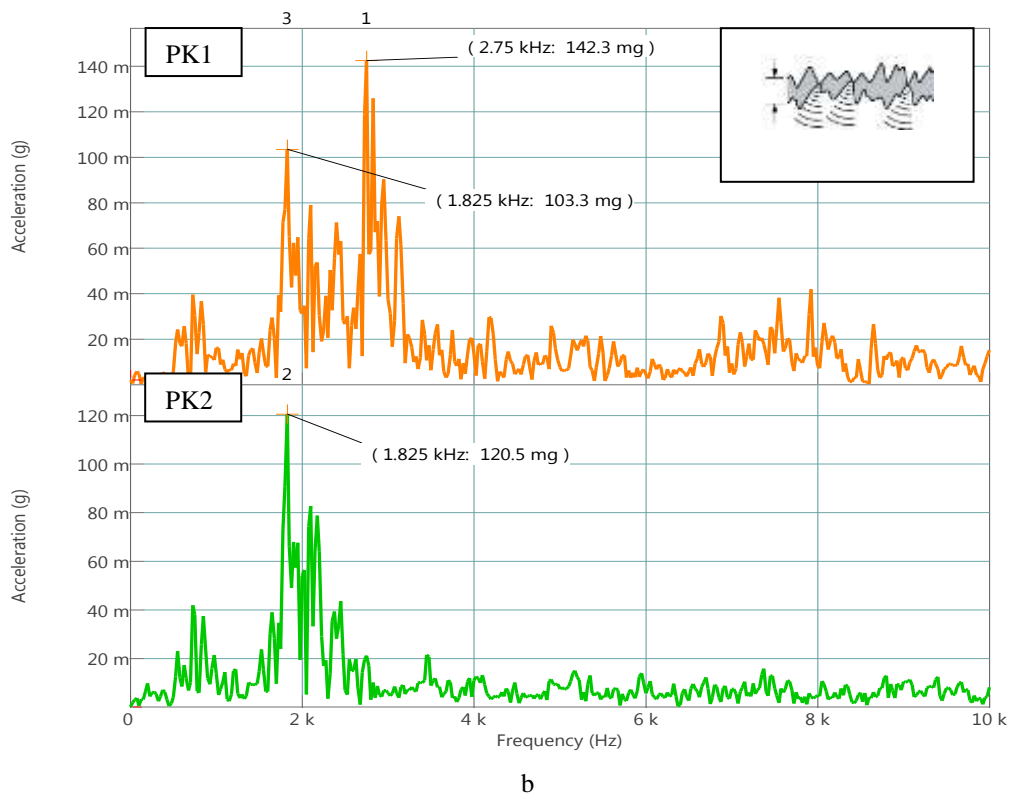
Fig. 4 Vibration acceleration spectra with grease lubricant (a) and without grease lubricant (b), with preloads $F_1=100$ N: PK1 transducer output upper and PK2 transducer output lower plots

The vibration acceleration spectra acquired from acceleration-time signals (Fig. 3, a, b) are shown in Fig. 4, a, b. Outer and inner ring raceways and balls stochastic vibration were damped by the grease. Vibration acceleration spectra (Fig. 4, a) indicated low frequency 700 Hz vibration acceleration amplitudes in the spectra of both PK1 and PK2 transducers output signals. This frequency was generated by $z = 9$ balls rotating about their own axes, but not of the micro-defect. The vibration acceleration spectra of dry bearing indicated dominating high frequency

of 2 750 Hz and 1825 Hz (Fig. 4, b). The high frequency of 2750 Hz vibration acceleration at 1.4 m/s² amplitude was measured with PK1 accelerometer indicated the first resonance frequency of the outer ring. The vibration accelera-

tion frequency of 1825 Hz indicated outer raceway and balls dynamic shocks excited vibration when bearing was tested without grease (Fig. 4, b).

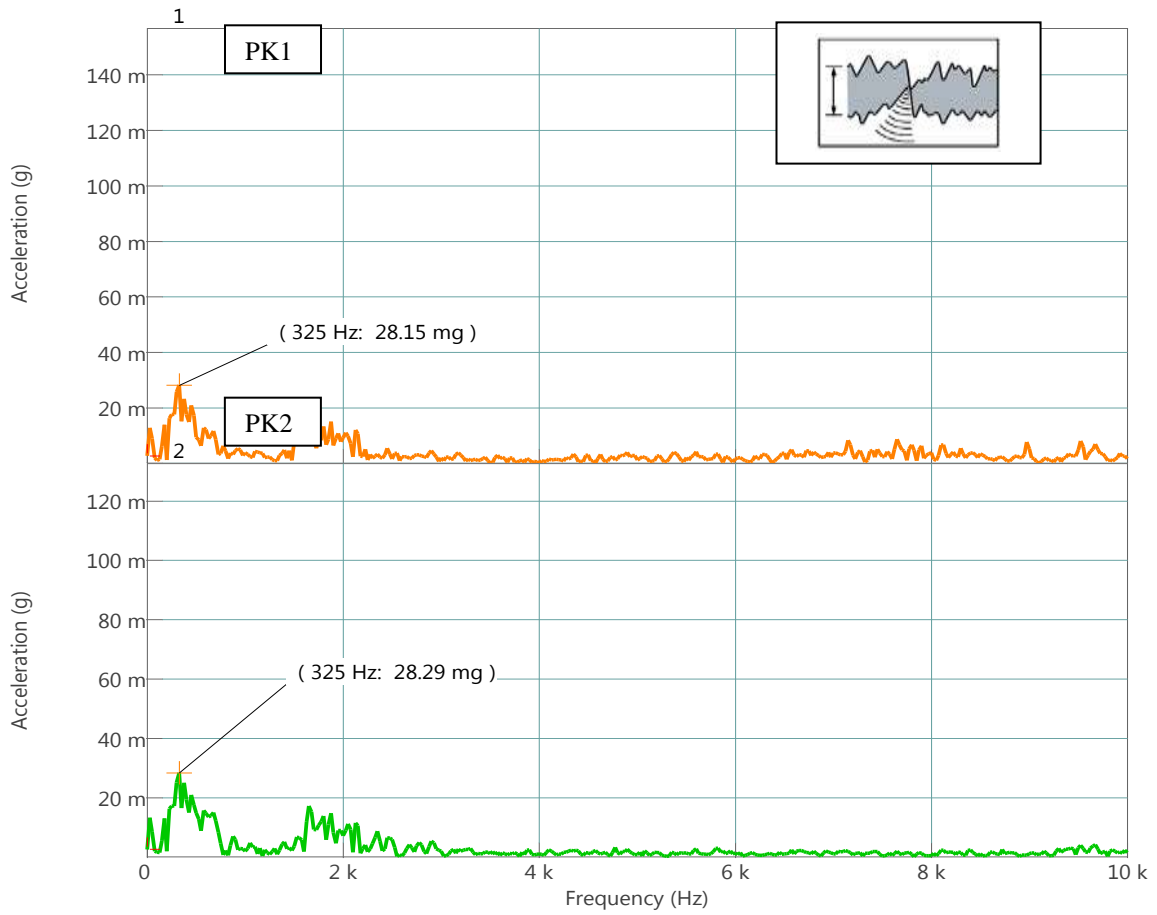
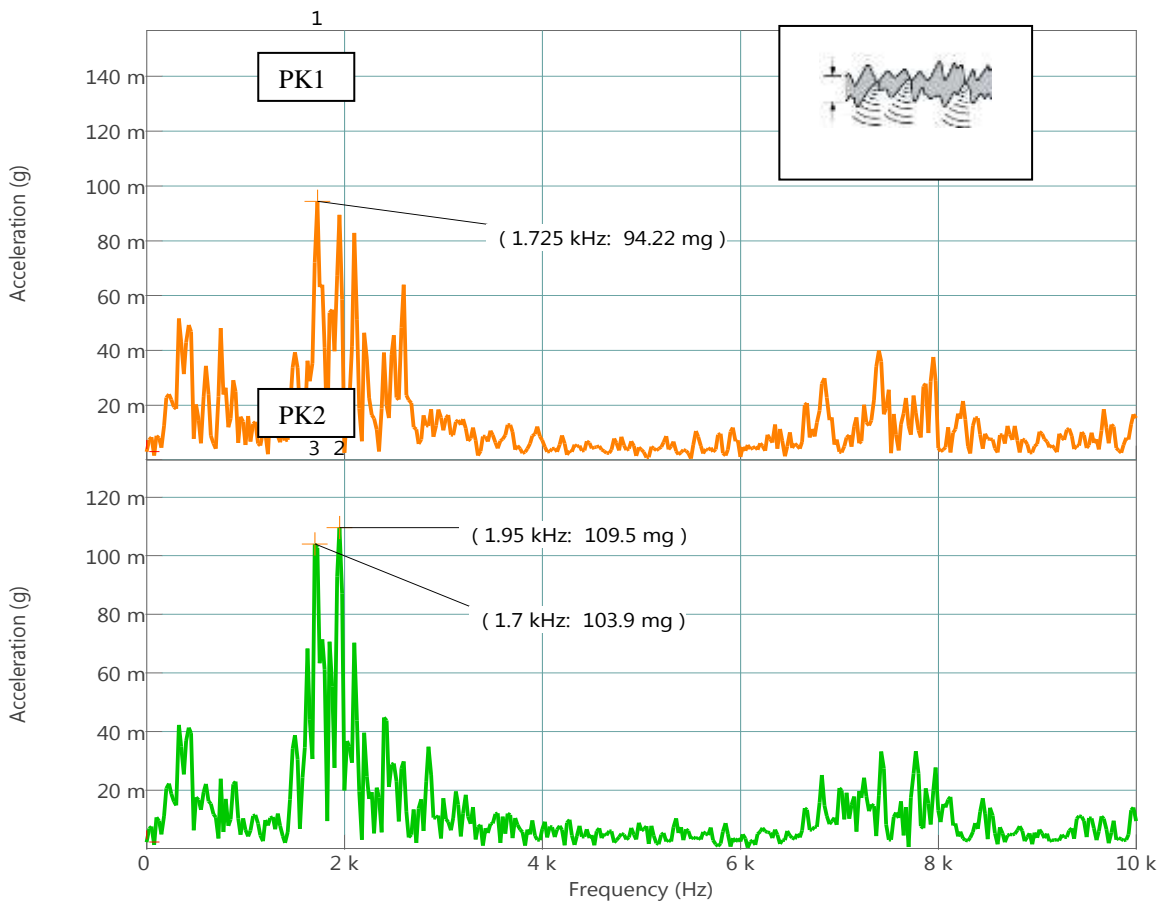
Fig.5 Vibration acceleration spectra with grease lubricant (a) and without grease lubricant (b) bearing without preloads $F_1=0$ N: PK1 transducer output upper and PK2 transducer output lower plots

son with loaded bearings and shown in Fig. 5, a and dominated low frequencies 325 Hz. Vibration intensity is of the

same values measured with accelerometers PK1 and PK2. The vibration acceleration spectra of dry bearing indicated the dominant harmonics of high frequencies in the range from 1700 up to 2800 Hz including outer ring resonance frequency (Fig. 5, b). These high frequency vibration accelerations are generated by shocks of outer and inner

raceways and balls micro-defects, were characterized by maximum roughness depth R_{zMax} . The low frequency magnitudes were negligible. The vibration acceleration frequency 1700-2750 Hz indicated outer raceway and balls dynamic shock frequencies, resonance when bearings were tested without grease (Fig. 5, b).
