# Study of the damage by acoustic emission of two laminate composites subjected to various levels of loading in three points bending

M. Kharoubi\*, L. Fatmi\*\*, R. Berbaoui\*\*\*, S. Bemedakhene\*\*\*\*, A. El Mahi\*\*\*\*\*

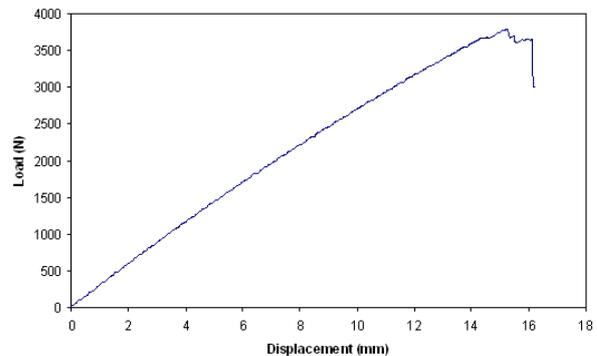
Fig. 2 Load-displacement curves: a - material 1, b - material 2

The Fig. 2 represents a load-displacement curves during load in tree points bending in static tests until rupture.

The calculation of the mechanical characteristics in 3 points static bending is based on the Eq. (1) for bending stresses  $\sigma_f$  and on the Eq. (2) for the values of the bending modulus  $E_f$ .

For material 1, the modulus equal to 23857.96 MPa while for material 2 the modulus is 20141.25 MPa.

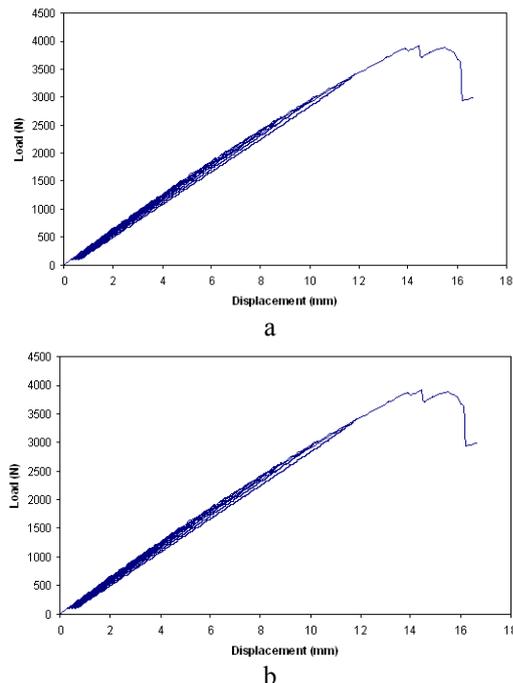
The specimen undergo a growing load by the step of 10 % of the static load at rupture. For each step an unloading is applied until zero value, only the last cycle is maintained until rupture. The load-displacement curves in load and unload - displacement obtained are presented in Fig. 3.

Fig. 3 Load, unload – displacement curves: a - material 1, b - material 2

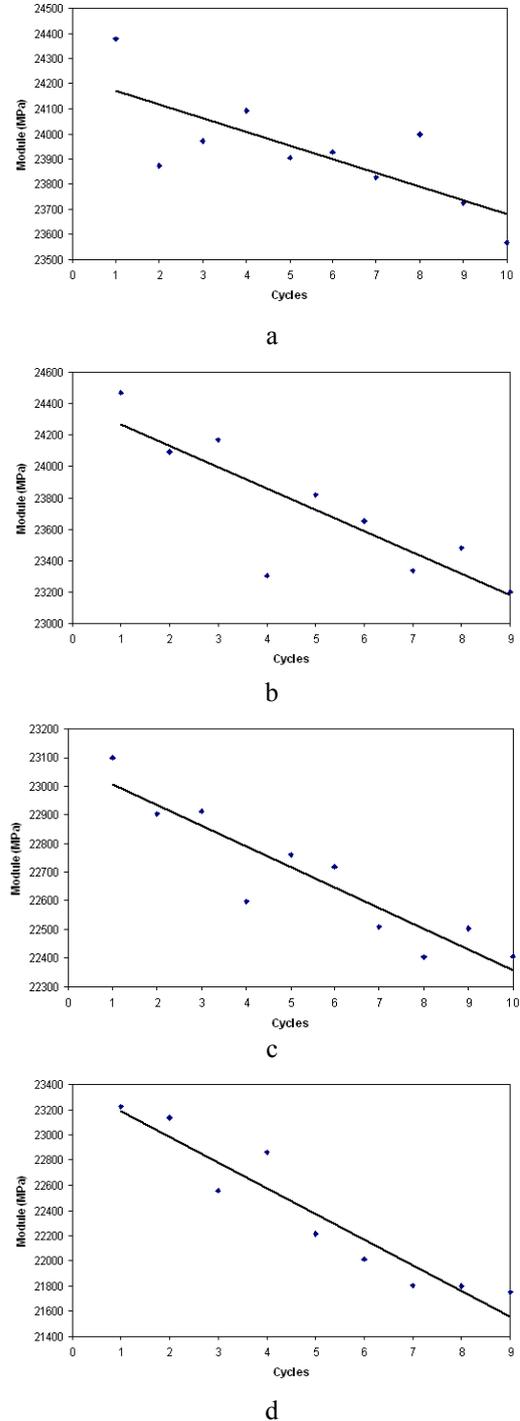
The bending modulus in load and unload are obtained according the Eq. (2). The corresponding values are presented in Tables 2-5. The modulus evolution according of the cycles number under loading and unloading is represented on Fig. 4.

Fig. 4 Modulus by step of load as the function of cycles number: a - loading of material 1, b - unloading of material 1, c - loading of material 2, b - unloading of material 2

The results obtained show that the increase in the number of cycles in loading or unloading involves a linear reduction of the modulus of elasticity of the two studied

materials; this reduction is probably related to the appearance of microcracks. These microcracks influence the mechanical behaviour of the specimen and particularly in terms of macroscopic properties such as module degradation. The fact that rigidity of the material is affected during the loading-unloading it is essential to measure the elastic modulus in order to be able to quantify the damage [5, 6], thus giving an idea on the evolution of the total damage of the material. Damage is determined by

The evolution of the damage parameter  $D$  during the loading – unloading tests in 3 points bending is a direct technical characteristic. It is obtained by measuring the Young modulus of the damaged material from the curves load–displacement (Table 2-5).

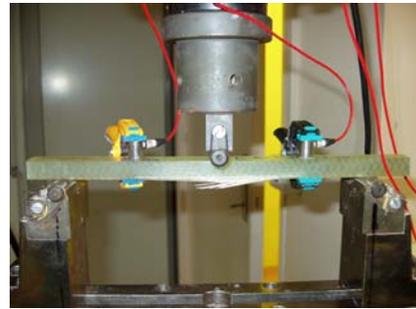
To confirm the results of mechanical behaviours obtained at experimental tests in 3 points static and cyclic bending, we have applied an experimental procedure of acoustic emission. It is based on a system of acquisition (EPA) including 2 ways. This system is composed of a chart PCI-2 and a microcomputer. Signals of acoustic emission are converted by 2 piezoelectric differential sensors of R10 type, resonating at 250 (325) kHz and with contact surface of 10 mm diameter. These signals are then amplified by a preamplifier with 40 or 60 dB gains, in a band of frequencies between 175 and 1000 kHz. The signals are then converted by the chart PCI-2 which digitizes them and proceeds to the extraction of the acoustic emission parameters. The data resulting from the charts are transmitted to the microcomputer, in real time of acquisition; storage and post processing are done using a program prepared under MATLAB. Fig. 5 shows the set-up of acquisition of acoustic events

Fig. 5 Set-up for the acoustic events

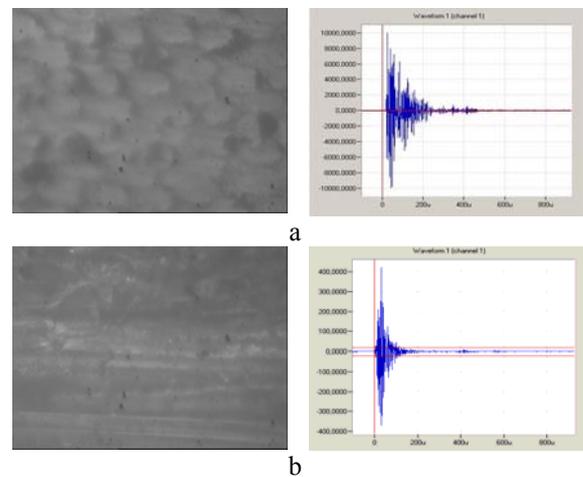
Figs. 6 and 7 represent respectively the mechanisms of damages and rupture observed under the optical microscope and located by acoustic emission during 3 points static and cyclic bending of materials 1 and 2.

Fig. 6 Mechanisms of damage and rupture in static bending of the material 1: a - interface rupture, b - interfolds rupture

A perfect correspondence resulted between the mechanisms observed under optical microscope and those

obtained by acoustic emission which are principally of three types: in static and cyclic load, i.e. rupture of fibres, rupture of the interface, and delamination rupture.

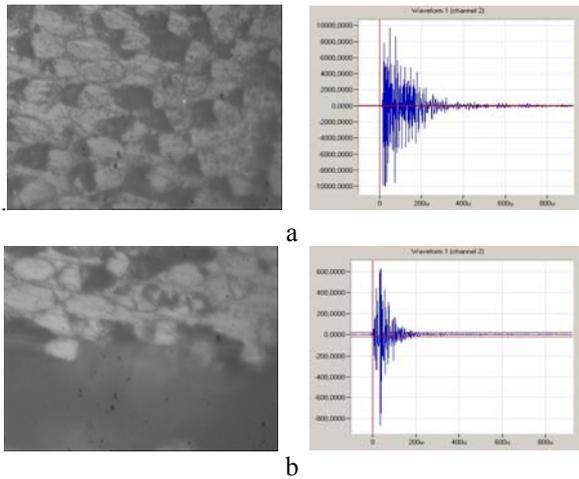
Fig. 7 Mechanisms of damage and rupture in cyclic bending of the material 1: a - interface rupture, b - interfolds delamination

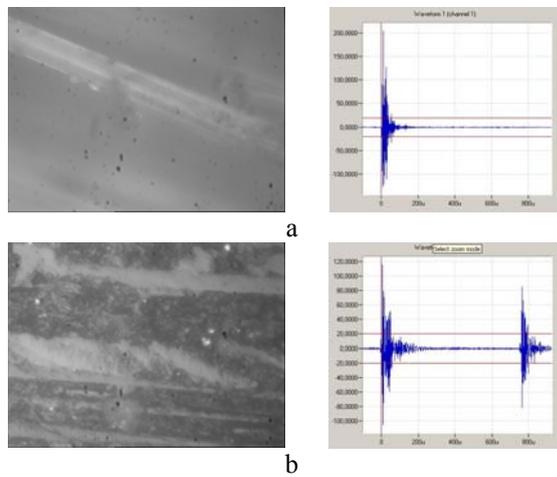
In the same way Figs. 8 and 9 represent respectively the mechanisms of damage and ruptures observed under the optical microscope and located by acoustic emission for material 2 [-60/-30/0]<sub>10</sub>.

Fig. 8 Mechanisms of damage and rupture in static bending of material 2: a - rupture of fibres extended to  $0^\circ$ , b - interfolds delamination

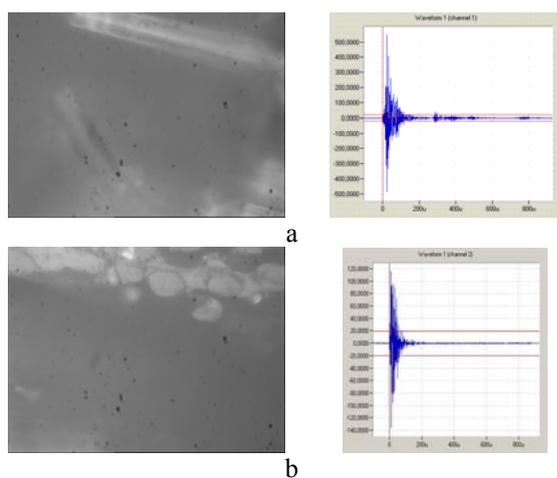
Fig. 9 Mechanisms of damage and rupture in cyclic bending of material 2: a - rupture of fibres extended to  $0^\circ$ , b - interfolds delamination
