# Predictive Maintenance of Rotating Machines, Application to the DHB Semolina Decorticator

### 1.1. Case study: DHB decorticator

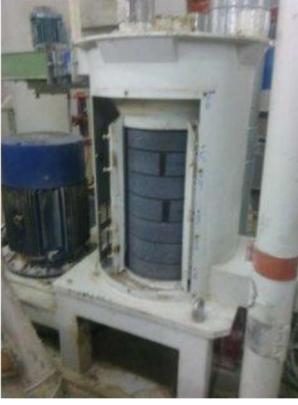
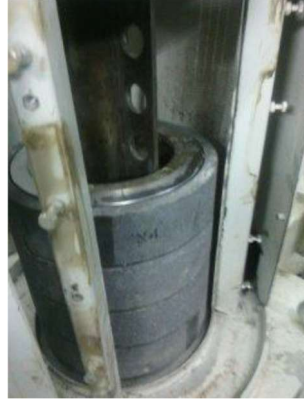
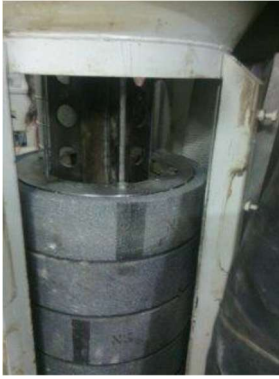
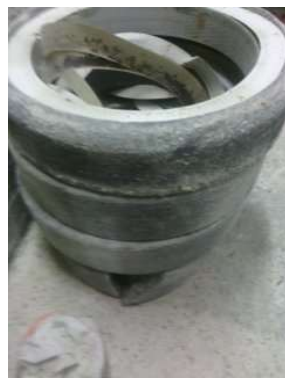
Figs. 2 to 5 show abrasive stones configuration.

Fig. 2 Assembly view

Fig. 3 Shaft and stones (first view)

Fig. 4 Shaft and stones (second view)

Fig. 5 Abrasive stones

The DHB decorticator is a strategic equipment in an industrial semolina mill. Located in the Mill Zone. Its role is to grind wheat particles using abrasive stones mounted in a column, as shown in Figs. 2-5. The setup consists of an electric motor with a power of 55 kW, operating at 1485 rpm, driving a vertical shaft on which seven abrasive stones are mounted. These stones have a diameter of 420 mm and a width of 100 mm (Fig. 4).

This unbalance problem is due to the beginning of wear on the abrasive stones mounted on the vertical rotor of the machine (Fig. 5). The work carried out: replacement of the abrasive stones.

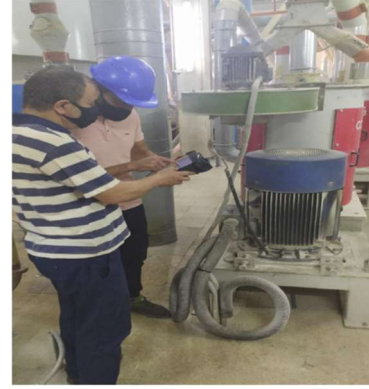
Fig. 6 Operation of vibration measurement sampling on the DHB decorticator

The machine is mounted on a concrete platform. The operational frequency of the machine is 21.25 Hz. The vibration amplitude at this frequency reaches 26.15 mm/s in terms of velocity, according to experimental results from spectral diagnostics. We consider the model represented in Fig. 7. The differential equations of motion are:

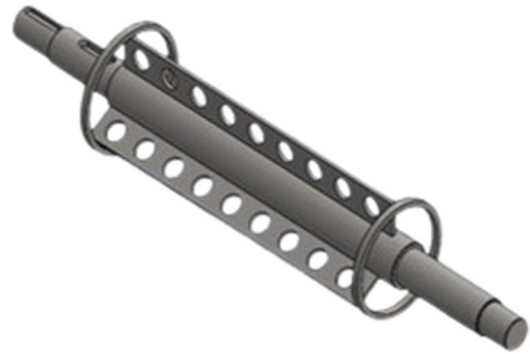
The rotor carrying the decorticator consists of a shaft with three different sections: diameters of 70 mm, 80 mm, and 100 mm. It is made of stainless steel with a length of 1455 mm. The abrasive stones are mounted along the length of the shaft with a diameter of 100 mm.

Fig. 18 Modelling of the system without abrasive stones by SolidWorks

- Increase in the width of both the upper and lower hoops, fixing the abrasive stones in stainless steel by 5 mm each from 11 mm to 16 mm in width (Fig. 18).

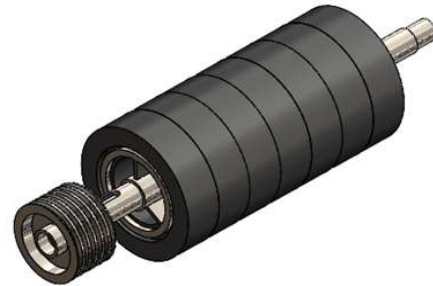
The receiving pulley is made of cast iron with a diameter of 250 mm. There are seven abrasive stones, each with an outer diameter of 420 mm, carried over a length of 835 mm. The total mass of the stones is 959 kg, and the limit conditions are rotational guidance at the bearings seen in Fig. 20. The meshing is illustrated in Fig. 21.

Fig. 19 Modelling the decorticator with abrasive stones using SolidWorks

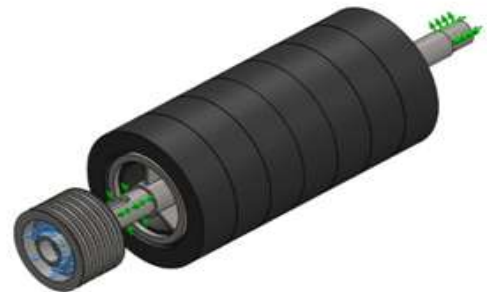
Fig. 20 Modelling and fixation conditions of the decorticator model

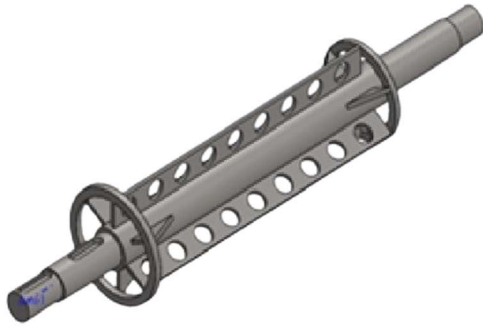
- The installation of three gussets in the form of a triangle in the upper and lower part of the decorticator's shaft. These gussets are placed to consolidate the hoop and the shaft of the decorticator in the upper and lower part. (Fig. 36).

Fig. 36 Modelling of the modified decorticator without abrasive stones

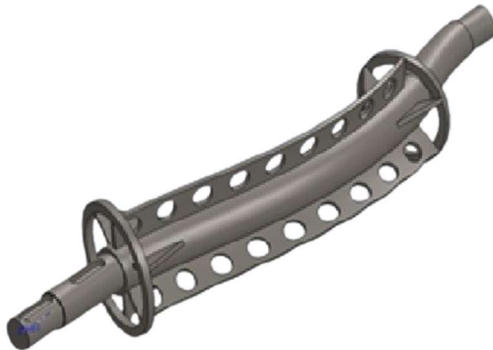
The modal deformation without abrasive stones is shown in Fig. 37. The mesh is represented in the Fig. 38.

Fig. 37 Deformation of the modified decorticator without abrasive stones

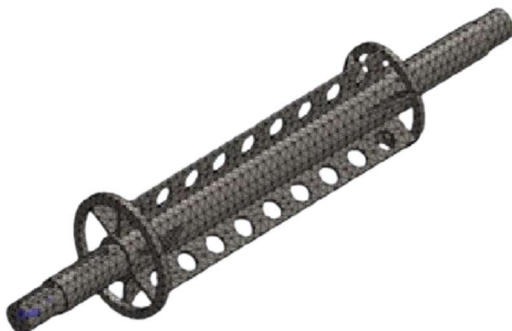
Fig. 38 Meshing on the modified decorticator without abrasive stones
