Analysis of some extreme situations in exploitation of complex rotary systems

R. Jonušas*, E. Juzėnas**, K. Juzėnas***

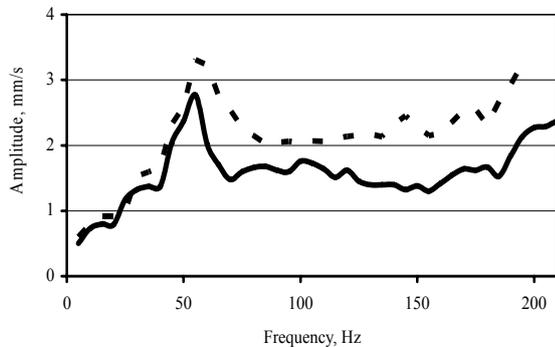
Fig. 3 Modelled amplitude – frequency characteristic of the 11th support vibrations. Solid line – machine is working in good conditions. Dashed line – rubbing occurs

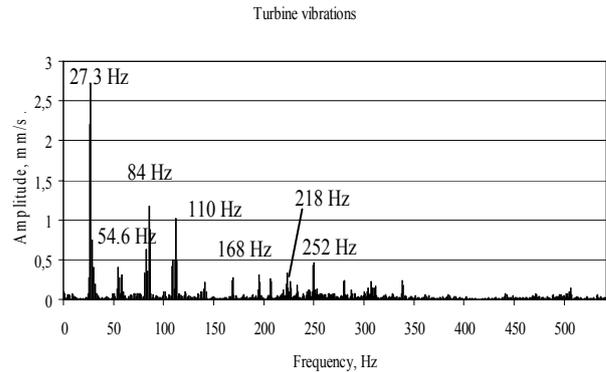
Fig. 4 Spectrum of the compressors 11th support vibrations when duration of the machine exploitation is similar to its typical interservice period

Experimental results present dynamical situation of the CRS when duration of the machine exploitation is similar to its typical interservice period. The second type of subharmonic vibrations (component of 27.3 Hz) can be seen as well as significant components of rotors rotation frequency 84 and 110 Hz. Rubbing of labyrinth sealing caused by thermal deformations of machine body is the possibly cause of the last component of vibrations. In this case, increased component of the rotation frequency is also caused by rubbing.

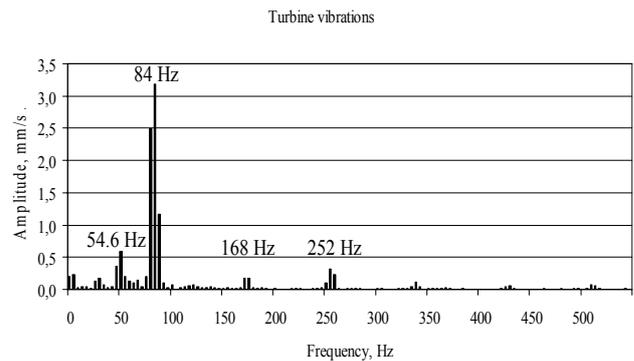
Spectrum of the machines 11[th] support vibrations after the breakdown of several turbine blades (as a possible result of rubbing) is presented in Fig. 5. Abnormally increased component of rotor rotation frequency is caused by significant unbalance of the broken turbine. Exploitation of the CRS is impossible in such conditions.

Fig. 5 Spectrum of the compressors 11th support vibrations after failure of some rotor blades

Such emergency situation could be foreseen analysing subharmonic vibrations of the machine, because it had been forming gradually in certain duration of time. Presumptively this situation was preceded by impacting of the CRS rotor blades to machines body that should be noticeable on the spectrum of vibrations as some increased subharmonic components. Accordingly rotor to stator rubbing was preceded by increased eccentricity of the rotor in bearings.

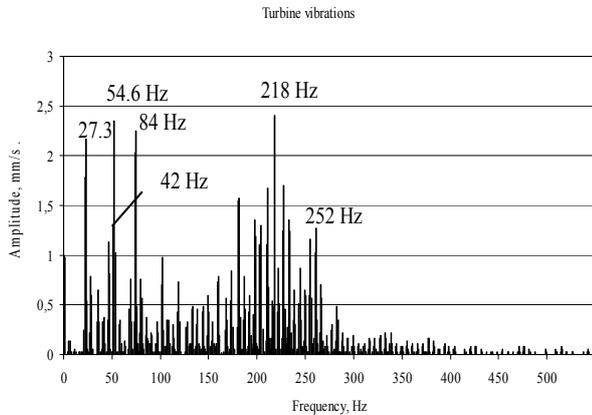
Fig. 6 presents spectrum of the 11th support vibrations in the case of rotor and stator blades partial rub-

bing. Very complex spectrum with multiple components of frequency of rotation as well as natural frequency (27.3, 54.6, 218 Hz, etc. and 42, 84, 252 Hz, etc.) can be noticed. There are also other subharmonic and super-harmonic, as well as chaotic components. Exploitation conditions of the CRS are unacceptable. Results of such machine failures (traces of rubbing) are presented in Fig. 7.

Fig. 6 Spectrum of the compressors 11th support vibrations in case of intensive rubbing

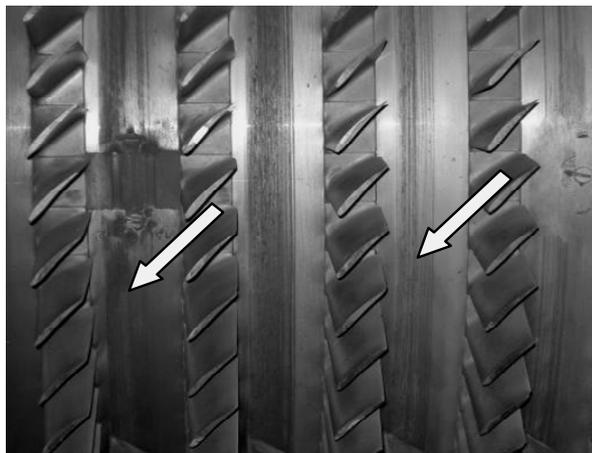
Fig. 7 Traces of rubbing between rotor and stator blades: a - traces of rubbing between rotor and blades of sta- tor, b - traces on rotor blades left by broken blades

Identification of the primary defects of the rotary system is very important aim of diagnostics, because, as it was mentioned, rubbing of rotors has to be considered as the secondary phenomenon, resulting from other defects. In this case, rubbing was caused by the poor quality of the machine assemblage. However those primary defects were relatively insignificant and were not detected during condi- tion monitoring of the machine.
