## Analysis of defects in stainless steel piping

R. Janulionis\*, G. Dundulis\*\*, R. Karalevičius\*\*\*

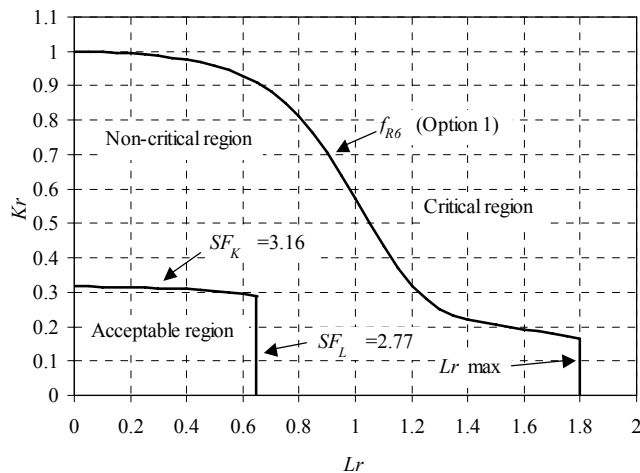
Fig. 2 R6 method

The evaluation of detected defects was made by R6 method option 1 [3] (Fig. 2). The R6 option 1 based only on yield and tensile strength values and leads to the most conservative assessment. This method was developed by Nuclear Electric plc [4]. The main idea of this method is that the crack is described by two variables  $K_r$  and  $L_r$ . Variable  $K_r$  is the relation between the stress intensity factor [5] and the factor which specifies the material resistance to crack growth. Variable  $L_r$  is the relation between the applied load and materials plasticity limit. The variation of these two variables is presented in the Fig. 2.

If the calculated value is in the region surrounded by coordinate axes and  $f_{R6}$  and  $L_r, max$  curves (non-critical region) the existing crack will not initiate the growth. However if the calculated value is outside this region the crack will grow and material can brake down. The acceptable region is the noncritical region just considering the safety factors. According the methodology [6] safety factors  $SF_K = \sqrt{10}$  and  $SF_L = 2.77$  should be used.

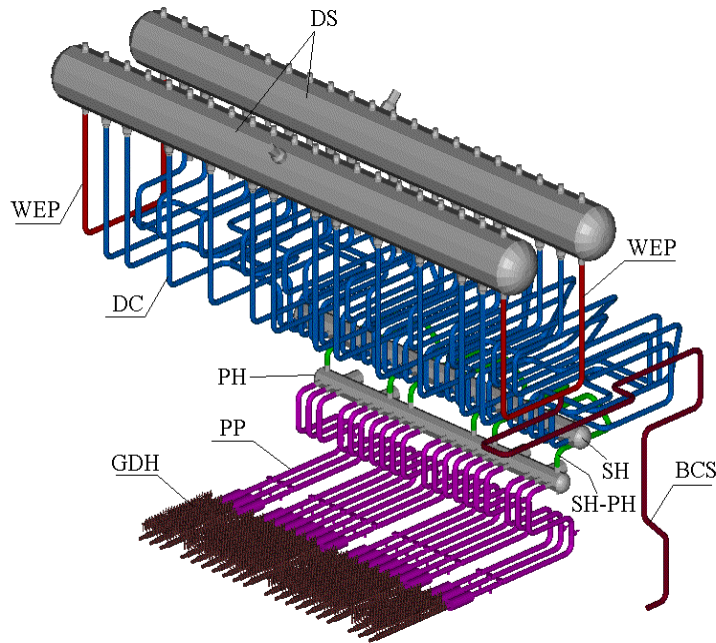
The evaluation objects are the defects detected in the MCC of RBMK type reactor (Fig. 3). This piping is made of 08X18H10T austenitic stainless steel. The used mechanical properties of this steel are presented in Table [6, 10], here  $T$  is temperature,  $E$  is elastic modulus,  $\nu$  is Poisson's ratio,  $\sigma_y$  is yield stress,  $\sigma_U$  is tensile strength,  $K_{IC}$  is critical stress intensity factor. The outside diameter of the pipes is 325 mm and the wall thickness – 16 mm. As it can be seen from Table the worst material properties at working temperatures are in main material. To be more conservative material properties of the main steel were chosen for evaluation of detected defects.

As it is seen from Fig. 3 the piping system is quite complicate. Therefore the load combination of dead weight and pressure, membrane stress and thermal expansion is different in each particular place. The load combination to each weld was calculated in Report No. 10048500-3 [11].
