# Wear behaviour of CBN tool when turning hardened AISI D3 steel

H. Bouchelaghem\*, M. A. Yaltese\*\*, A. Amirat\*\*\*, S. Belhadi\*\*\*\*

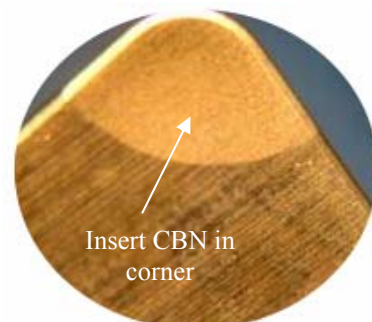
Fig. 1 CBN insert

The test specimens have been hardened to the required hardness of 60 HRC through quenching to 940°C and tempered at 280°C. Machining operations have been achieved on a 6.6 KW power TOS TRENCIN model SN40 lathe. A TiN layer covered cutting insert (57% CBN), of the standard designation SNGA120408 T01020 is mounted on PSBNR2525K12 (Fig. 1), tool holder with an active part tool geometry characterised by the following angles:  $\chi_r = 75^\circ$ ;  $\alpha = 6^\circ$ ;  $\gamma = -6^\circ$ ;  $\lambda = -6^\circ$ . Wear has been measured using a CCD camera equipped HUND optical microscope (W-AD).

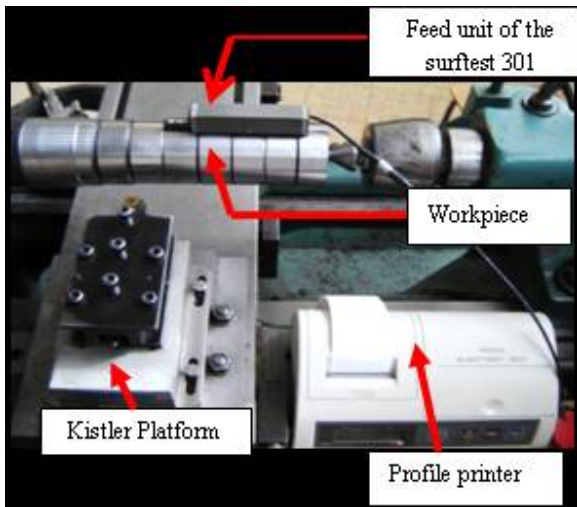
Fig. 2 Layout of the equipment for Roughness measurement on the machine

All roughness measurements have been obtained directly on the machine and without disassembling the workpiece (Fig. 2) by means of a SurfTest 301 Roughness meter. The cutting forces have been measured in real time within the three components according the directions  $X$ ,  $Y$  and  $Z$ , using a quartz KISTLER 9257B standard dynamometer. A distance IR pyrometer with, Rayner models 3I, (-30 to 1200°C) has allowed to record temperatures in the cutting zone. Wear has been investigated without lubrication under the following cutting parameters: feed rate ( $f$ ) of 0.08 mm/rev, cut depth ( $a_p$ ) of 0.5 mm and a cutting speed ( $v_c$ ) range of 85 to 310 m/min. An allowable wear value [ $VB$ ] of 0.3 mm is adopted for the CBN tool life. However wear values have been obtained beyond this limit in order to observe the global CBN tool behaviour, under extreme conditions.

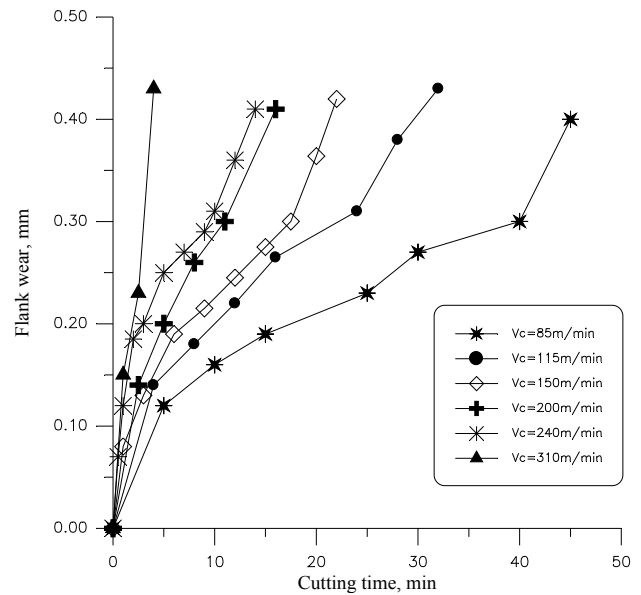
Fig. 3 Evolution of flank wear ( $VB$ ) as the function of cutting time

Long term wear tests according to ISO 3685 have been carried out through straight turning in order to evaluate CBN tool life for various cutting speeds. These tests provide reliable results closer to industrial reality [22, 23]. Results on CBN tool wear evolution (flank and crater) as a function of cutting time for a cutting speed range of 85, 115, 150, 200, 240 and 310 m/min, are illustrated in Fig. 3 and Fig. 4. It can be clearly seen that the wear trend obey the universal wear law of any mechanical workpiece (wearing, normal wear, accelerated wear). However the cutting speed has a great effect on the wear behaviour as a rapid increase of the wear started from the cutting speed of 115 m/min. As a consequence the extent of the normal wear zone is considerably reduced; this is justified when testing at 85, 150 and 310 m/min. At 85 m/min, the normal wear zone extends during 35 min, at 150 m/min; it requires only 15 min, whereas at 310 m/min the normal wear zone is almost nonexistent. Moreover, Fig. 4 reveals that the crater trend of wear  $KT$  is relatively weak comparing to wear  $VB$  therefore the principal criterion of tool life is the wear  $VB$  resistance [21].

Graphic analysis of the flank wear results ( $VB$ ) (Fig. 3) as a function of cutting time in the investigated cutting speeds allows to determine different CBN tool lives. It should be noted that the tool life ( $t$ ) has been obtained for the flank wear as the latter is very much higher than the crater wear specifically when the speed is increased. On the basis of two allowable wear criteria  $[VB] = 0.3$  mm and  $[VB] = 0.4$  mm, the obtained values of tool life are summarized in Fig. 7.

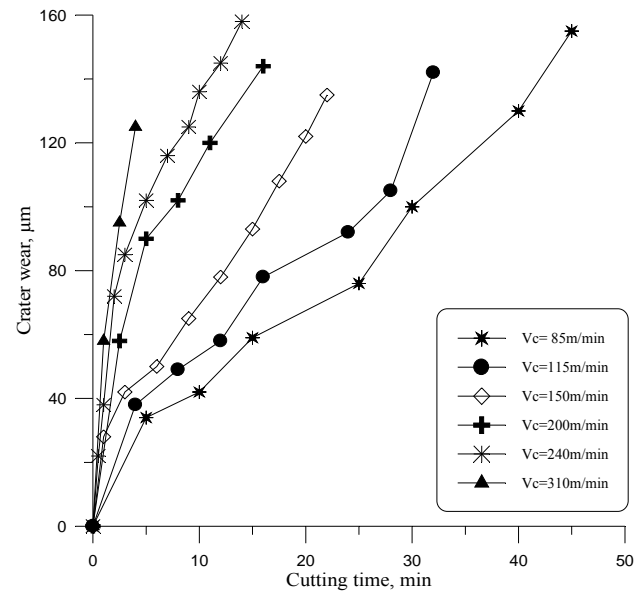
Fig. 4 Evolution of crater wear ( $KT$ ) as the function of cutting time

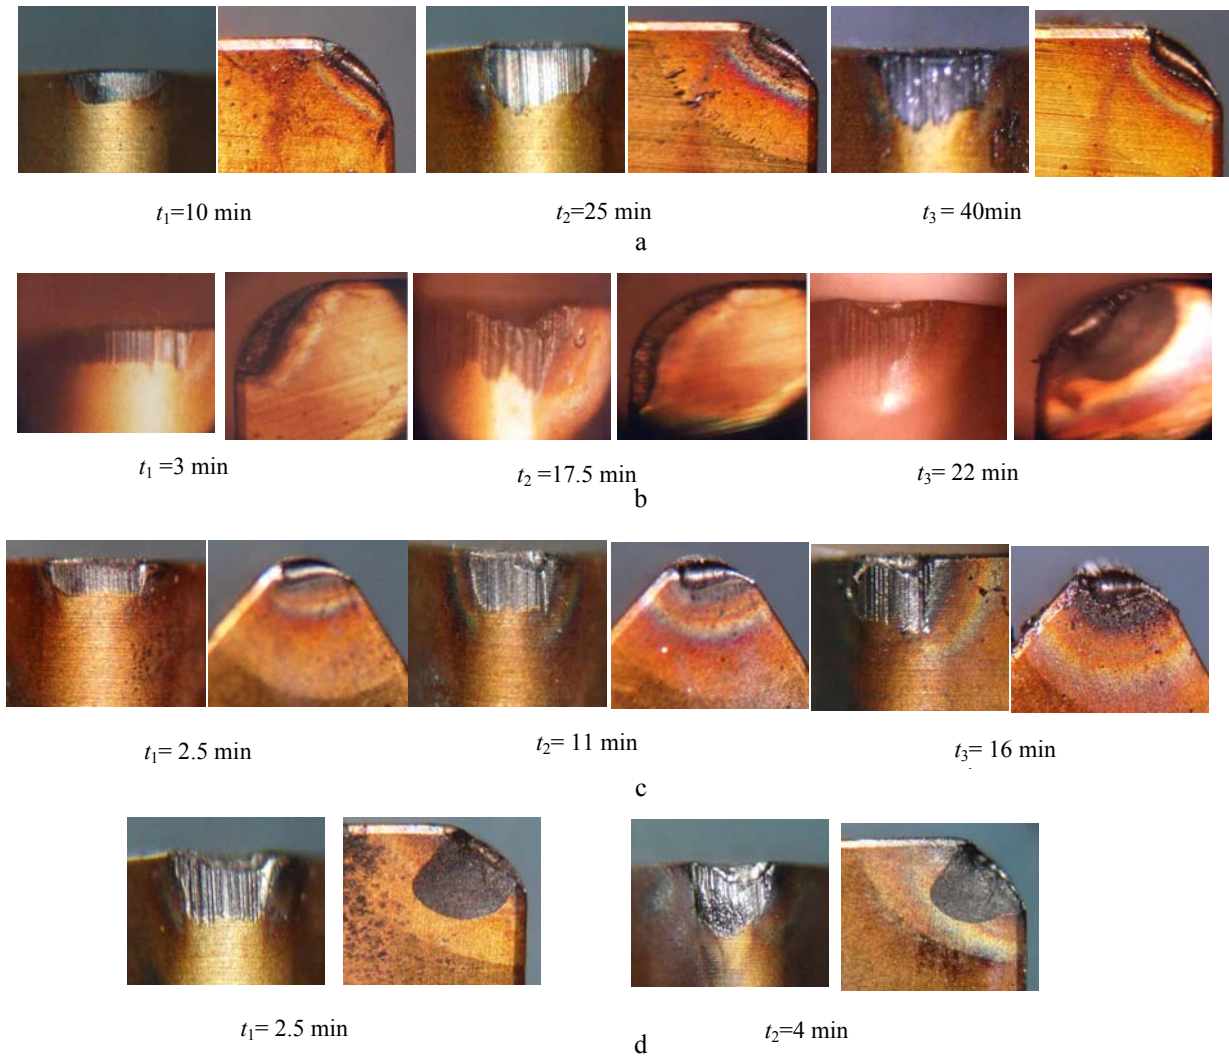
Fig. 5 Micrographs of flank and crater wear at various cutting speeds  $f = 0.08$  mm/rev and  $a_p = 0.5$  mm: a -  $v_c = 85$  m/min ; b -  $v_c = 150$  m/min ; c -  $v_c = 200$  m/min ; d -  $v_c = 310$  m/min

For cutting speeds of 85 m/min and 115 m/min, there was no difficulty in machining. The wear on flank surface is regular; at the beginning, it is manifested by the appearance of a grooved and shining band. When increasing the machining time, the  $VB$  value increases generating discontinuous chip. It is worth noting that the machining system is stable within these cutting speeds. The crater wear appears by a small cup on the rake surface in the first machining minutes and it extends with time (Fig. 5, a).

ter 17.5 min of machining, the wear  $VB$  expands in width and increases to becoming irregular. On the 22nd minute of work, machining becomes difficult showing fairly red colour discontinuous chips (Fig. 6). Chippings on the tool rake surface following the high stresses generated from the cutting process are observed. The rapid evolution of  $VB$  and  $KT$  has led to the collapse of CBN tool nose (Fig. 5, b).

At 200 m/min, at the beginning the machining is characterized by stability, by no chipping on the flank surface and the crater of the CBN insert, and by discontinuous red chip. After 2.5 min the flank wear appears with regular band (Fig. 5, c). At the 11th minute the  $VB$  value increases in width and the crater becomes wider. At the end, 16 min

At 310 m/min within 2.5 min of machining, the insert chamfer undergoes an accelerated wear caused by temperature increase, and chipping is observed on the rake surface. After 4 min, small collapse of the tool nose is noted. Machining lasted with chipping on the rake surface that propagates along the diagonal direction of the insert. There have also been grooves while wear  $VB$  is generating on tool flank, resulted from high abrasive wear (Fig. 5, d).

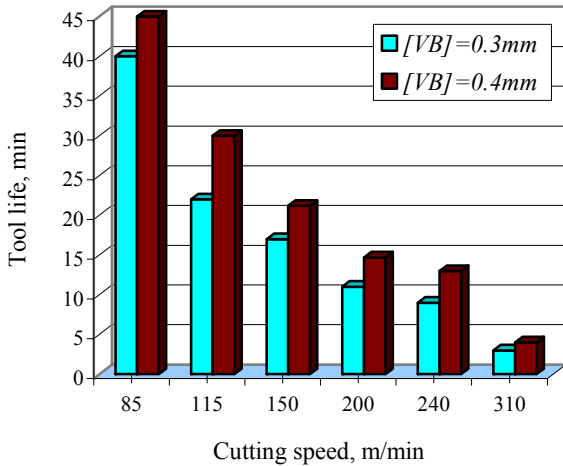
Fig. 7 Effect of cutting speed on CBN tool life

For the cutting speeds 85 to 115 m/min and the speed ratio of 1.35, the tool life falls by 45%. Increasing the speed range 115 to 150 m/min, for the speed ratio of 1.3, it is observed 23% of tool life fall. The corresponding tool life reduction, for the next three speed ranges 150 to 200, 200 to 240 and 240 to 310 m/min have been found respectively of 36%, 19%, and 67%. There is obviously a great sensitivity of lifetime to cutting speed variation. For higher speed ranges 240 to 310 m/min, this effect is even more significant on the tool life that dropped down by 67%. This can be explained by the presence of high temperatures generated by the cutting process around the tool nose, supporting various wear mechanisms (abrasion and diffusion) and consequently the cutting tool capacity decreases. Even more when working at high cutting speeds, the mechanical and thermal solicitations increase on the cutting edge. As a consequence frictions and high

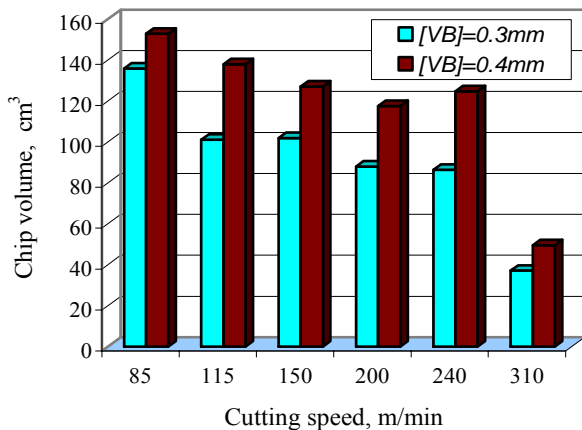
Fig. 8 Effect of cutting speed on the generated chip volume

Fig. 8 illustrates the chip volume produced during AISI D3 steel machining at various cutting speeds for the two wear criteria  $[VB]=0.3$  mm and 0.4 mm. It can be clearly seen from the results that for the cutting speed of 85 m/min there have been better performance as the volume  $V$  respectively to the values of wear criteria is equal to 136 cm<sup>3</sup> and 153 cm<sup>3</sup>. The smallest chip volume values  $V=37.2$  cm<sup>3</sup> and  $V=49.6$  cm<sup>3</sup> corresponding to the allowed values of wear are obtained for the cutting speed of 310 m/min.

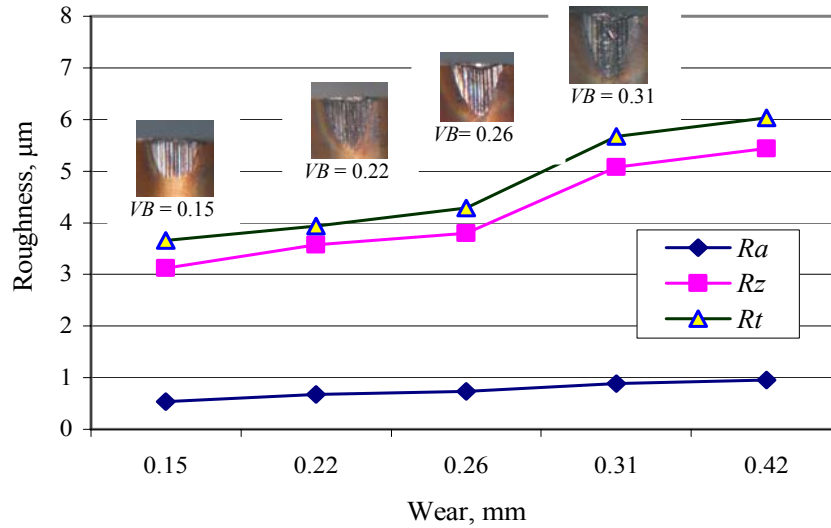
Fig. 9 Influence of wear on roughness at  $v_c = 115$  m/min;  $f = 0.08$  mm/rev;  $a_p = 0.2$  mm

Results on roughness evolution as a function of wear  $VB$  are illustrated in Fig. 9 and Fig. 10, for 115 and 160 m/min cutting speeds. There is neither stable nor uniform roughness value for criteria ( $R_a$ ,  $R_z$ ,  $R_t$ ) during the cutting, but roughness is subjected to sudden increase as a function of machining time, i.e. with wear resistance. Therefore superficial damage obtained on of the faces and cutting edges of the active tool part leads to the degradation of surface roughness of machined material. The curves also show that CBN ensure good surface quality during a large spare machining time. At 115 m/min and after 32.5 min of cutting roughness  $R_a$  has not exceeded 1  $\mu$ m, similarly at higher speed  $v_c=160$  m/min,  $R_a$  remains lower than 1  $\mu$ m within 20 min of machining.

In addition with regard to roughness-wear  $VB$  curves (Fig. 9 and Fig. 10) a general mathematical model is proposed in the equation

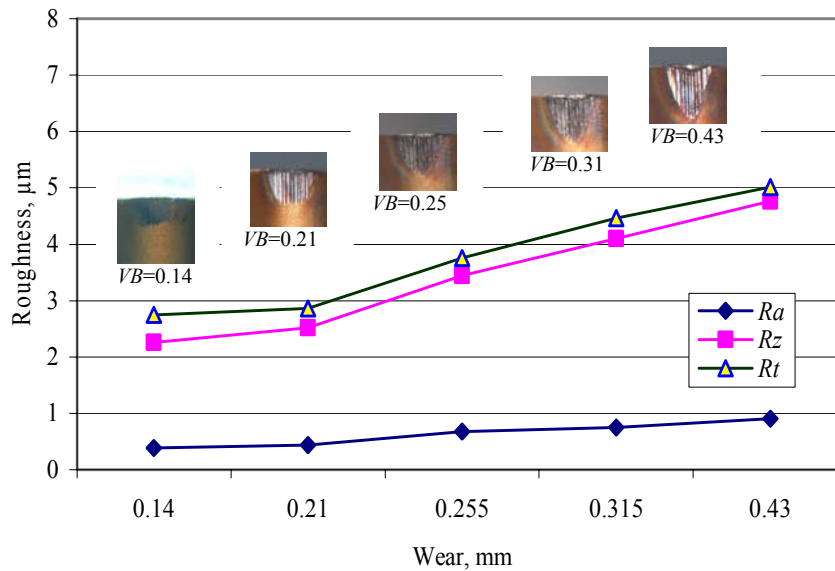
Fig. 10 Influence of wear on Roughness at  $v_c = 160$  m/min;  $f = 0.08$  mm/rev;  $a_p = 0.2$  mm

The change in the roughness behaviour as the function of  $VB$  wear can be explained through microscopic observations of the tool nose. Fig. 10 shows increasing wear micrographics describing the transition from low roughness value ( $VB=0.14$  mm), to high value ( $VB=0.31$  mm) and the zone with higher roughness value ( $VB=0.43$  mm), for the cutting speed of 160 m/min. 4 min machining generate a weak wear bandwidth that is appreciable with constant total roughness ( $R_t=2.75$   $\mu$ m). 8 min machining reveals an increase in the width of wear band with the formation of small grooves on the flank face (abrasion wear). After 12 min of machining, the thermomechanical solicitations increase on the cutting edge, causing various forms of the CBN tool wear resulting in a total roughness value  $R_t$  of 3.44  $\mu$ m and a  $VB$  of 0.25 mm. When machining ended after 20 min, the tool undergoes rapid wear degradation ( $VB=0.43$  mm), where a small collapse on the tool CBN nose is observed leading to the machined surface quality drop ( $R_t=5.01$   $\mu$ m). Finally at  $v_c=160$  m/min, the  $VB$  wear increase from 0.14 to 0.43 mm led to roughness values increase ( $R_a$ ;  $R_z$ ;  $R_t$ ) respectively by 130.76%; 110.61%; 82.18%.

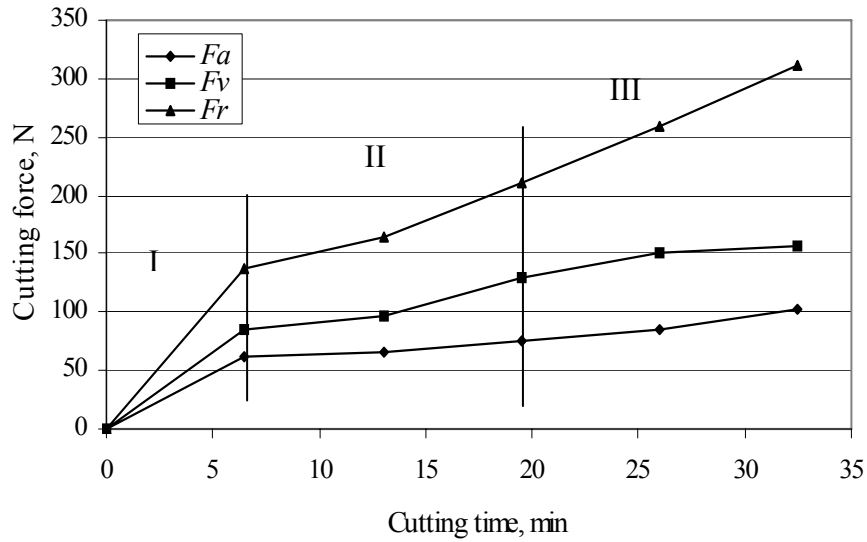
Fig. 11 Effect of cutting time on cutting force at  $v_c = 115$  m/min;  $f = 0.08$  mm/rev;  $a_p = 0.2$  mm

Fig. 11 and Fig. 12 show the evolution of cutting forces as a function of cutting time and wear. There is an increase in the cutting force components as a function of cutting time. This is due to wear evolution on the attack and flank surfaces of the tool. As a consequence the workpiece-tool contact surface increases together with the friction forces generating higher cutting forces.

The first stage lasted 6.5 min and corresponded to  $VB$  wear of 0.15 mm, the cutting forces ( $F_r$ ,  $F_a$  and  $F_v$ ) recorded were respectively 137.82, 61.5 and 85.22 N. The

second stage varied from 6.5 to 26 min of machining, where the measured wear  $VB$  increased from 0.15 to 0.31 mm, causing an increase in the cutting forces ( $F_r$ ,  $F_a$  and  $F_v$ ) of respectively 87.96, 39.77 and 76.07%. In this stage the evolution of the cutting forces is more accentuated than during the first stage. The third stage was characterized by a fast evolution of wear  $VB$  value passing from 0.31 to 0.42 mm during a spare time of 26 to 32.5 minutes of machining. At this stage the cutting forces reached maximum values with an increase of 20.47, 19.11 and 4.84. When comparing the evolution of the cutting forces ( $F_r$ ,  $F_a$  and  $F_v$ ) from the beginning to the end of machining, there has been respectively 126.44, 66.48 and 84.60% increase. Fig. 5 shows micrographics of the CBN tool flank taken at various wear stages.

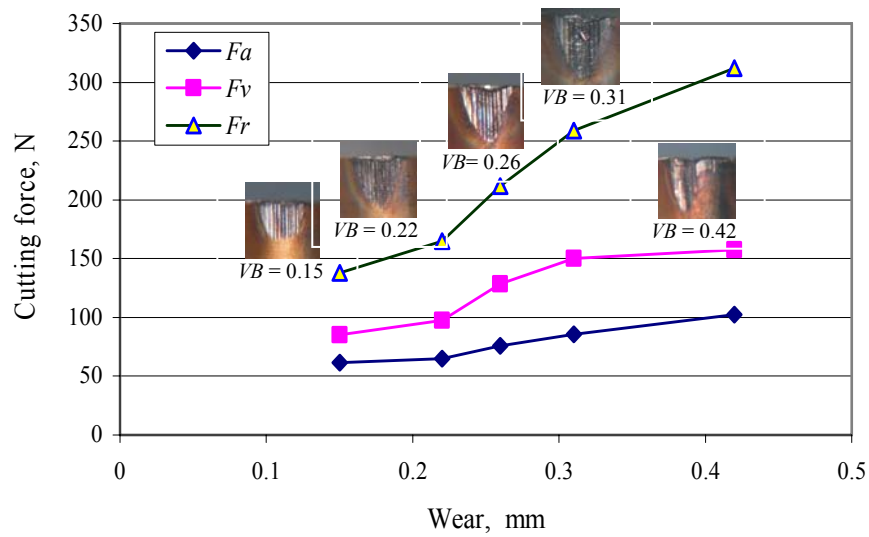
Fig. 12 Influence of wear on cutting force at  $v_c = 115$  m/min;  $f = 0.08$  mm/rev;  $a_p = 0.2$  mm

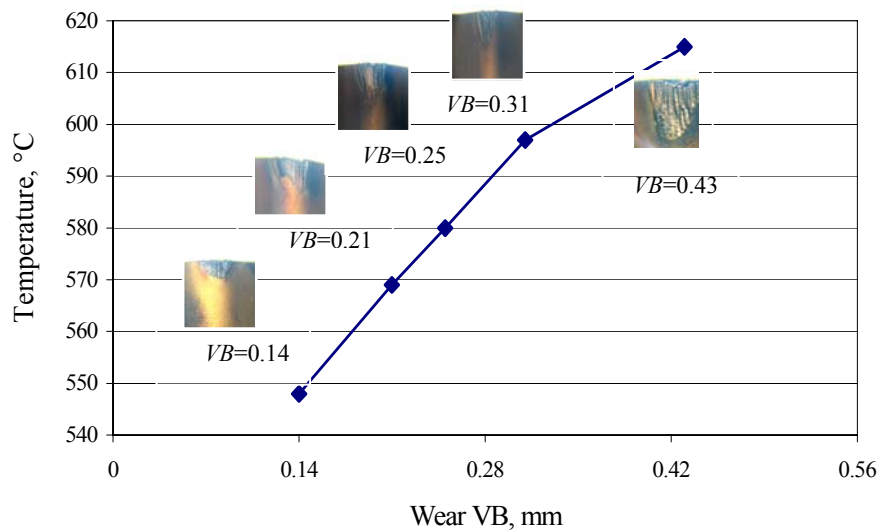
Fig. 13 Influence of wear on maximum recorded value of temperature in the cutting zone at  $v_c = 160$  m/min,  $f = 0.08$  mm/rev,  $a_p = 0.2$  mm

The cutting tool wear is the most influencing parameter during machining of hard materials [10, 15, 19, 21, 26]. Fig. 13 illustrates the evolution of cutting temperature

as a function of wear  $VB$ . The longer the cutting time the larger the wear therefore the temperature generated in the cutting zone increases significantly. Within 4 minutes temperature reaches  $548^\circ\text{C}$  while the flank wear is weak,  $VB=0.14$  mm. As contact surface between the workpiece and tool increases in 12 minutes, because of increases in wear ( $VB=0.25$  mm), there is a rise in frictions and heating allowing the deterioration of cutting edges by physico-chemical phenomena [12]. The acceptable wear limit is reached after 16min of machining when small collapse of the CBN tool nose occurs and maximum temperature of  $597^\circ\text{C}$  is recorded. Later on after 20 min, catastrophic collapse of the nose is observed when  $VB=0.43$  mm.

Hence a mechanism of abrasion and diffusion [25, 26] occurs due to the amount of heating and higher values of cutting forces. At this stage, the maximum temperature of  $615^\circ\text{C}$  is recorded and the tool loses its cutting qualities by thermal fatigue. Finally it can be said that the three parameters (friction, temperature and wear) are closely related and mutually affecting each other. As a consequence when cutting frictions increase there is a rise in cutting

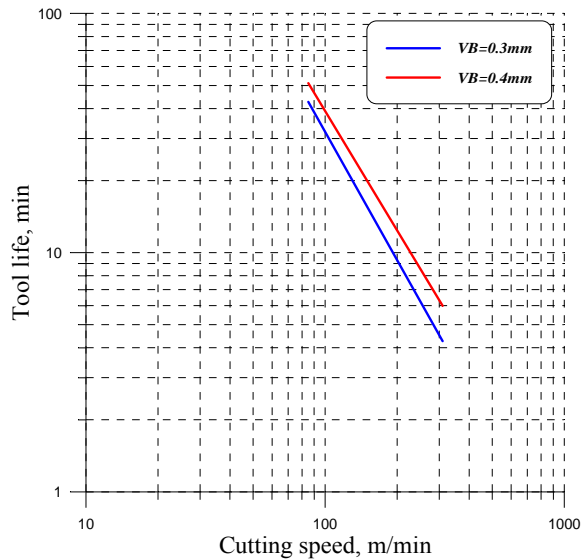
Fig. 14 Effect of cutting speed on tool life using Taylor straight lines

Then from equations (1) and (2) Taylor straight lines can be drawn on a bi-logarithmic scale (Fig. 14) for the two wear criteria  $[VB] = 0.3$  and  $0.4$  mm. These lines are economically very important since they allow to know the CBN tool life when machining AISI D3 steel hardened to 60 HRC, at any selected cutting speed ranging from 85 to 310 m/min.
